**ATTACHMENTS TO REPORTS OF THE BLAYNEY SHIRE COUNCIL MEETING
HELD ON MONDAY 16 MAY 2022**

11 Floodplain Management

Addendum to Blayney Flood Study
Update to Australian Rainfall and Runoff 2019 Guidelines

For Blayney Shire Council

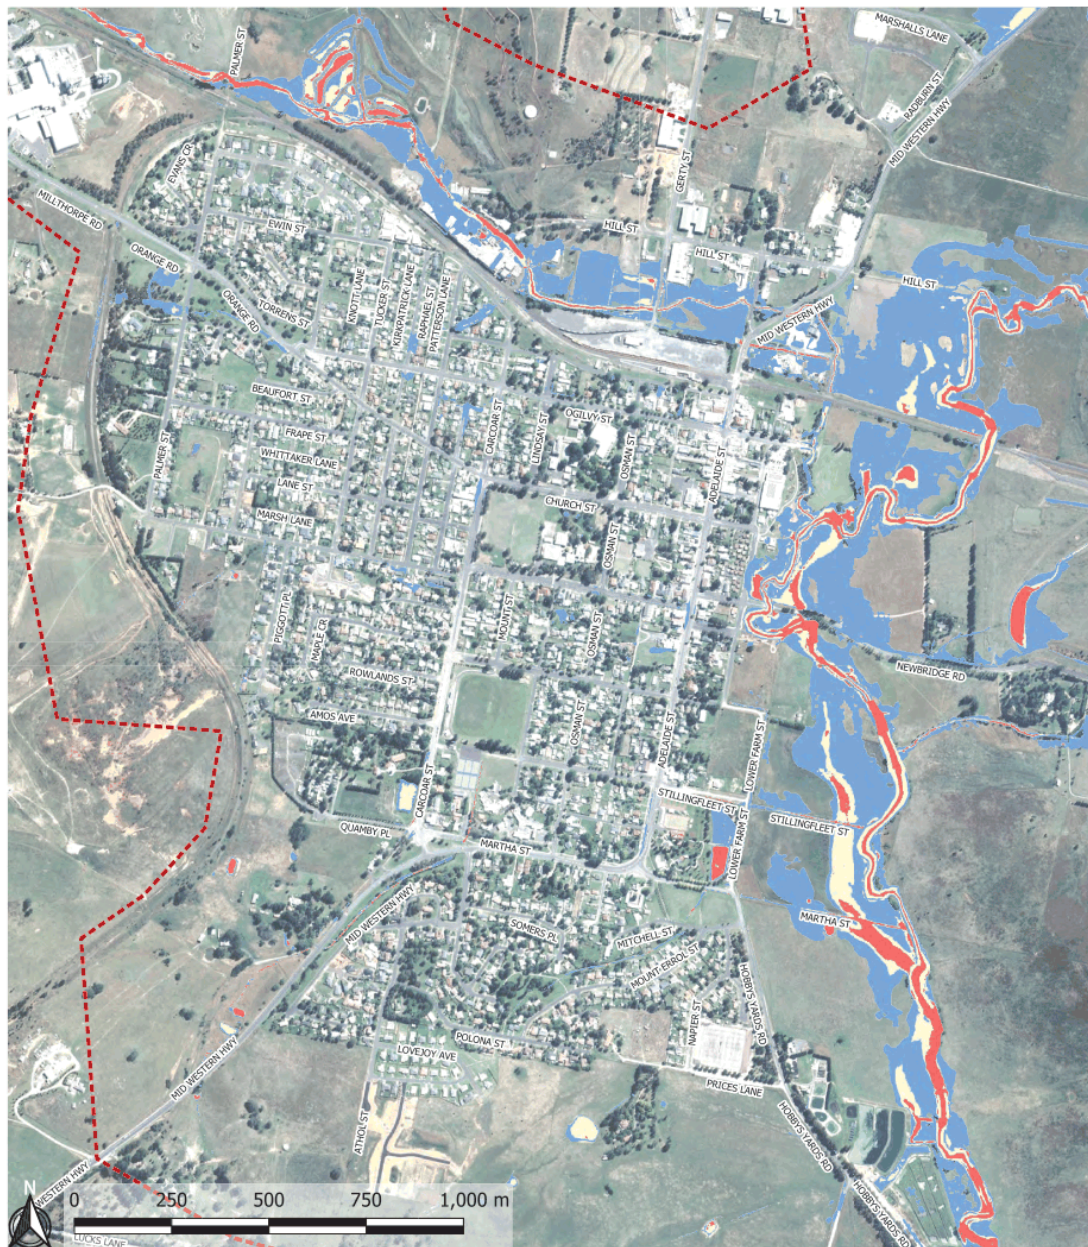
**Map 07: Existing Flood Hazard
20% AEP Event (ARR 2019)**

Note: A 150 mm cutoff depth has been applied to this map.

Hazard maps for the existing condition are shown in **Appendix A** as Maps 07-09 for the 20%, 5% and 1% storms. Hazard maps for the proposed condition are shown in **Appendix B** as Maps 17-19 for the 20%, 5% and 1% storms. These are shown for reference and are discussed in the 'Addendum to Blayney Floodplain Risk Management Study' (Storm, 2021).

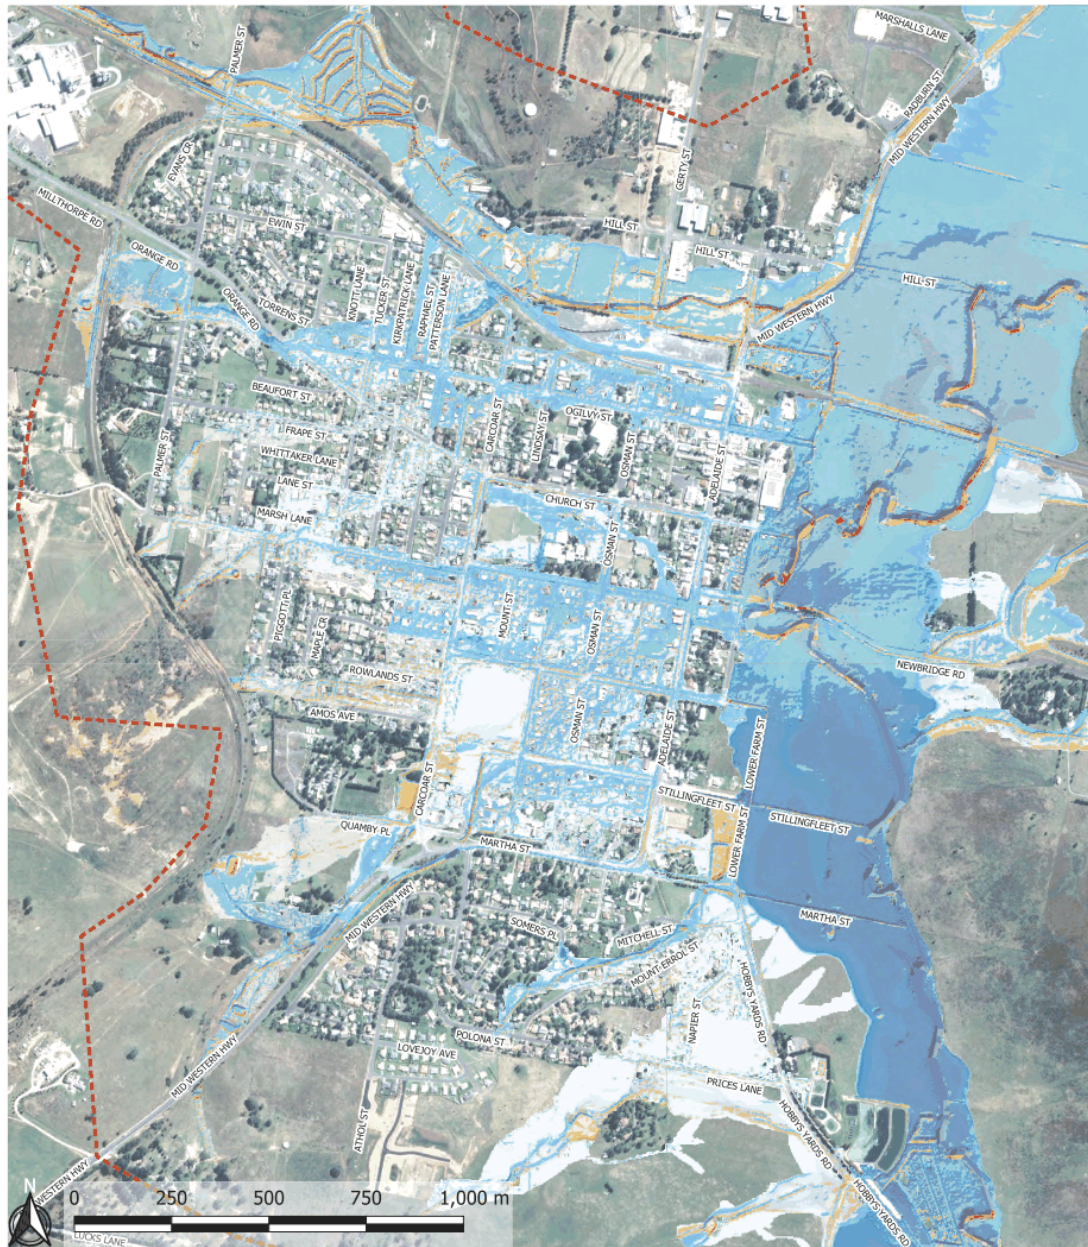
Map 10: Water Level Afflux
1% AEP Event (Storm's ARR 2019 - Jacobs' ARR 87)

Note: A 150 mm cutoff depth has been applied to this map.

An afflux map showing the water level differences between the ARR87 modelling and ARR19 modelling has been generated as Map 10 and shown in Appendix C. It shows a significant amount of change however the changes are relatively slight. For the most part, reductions are in the order of 0.01 to 0.2m throughout the township with only minor increases in depth in concentrated areas. These increases are primarily due to the higher rainfall runoff rates (as per ARR19 conditions) in the rural catchments to the west of town.

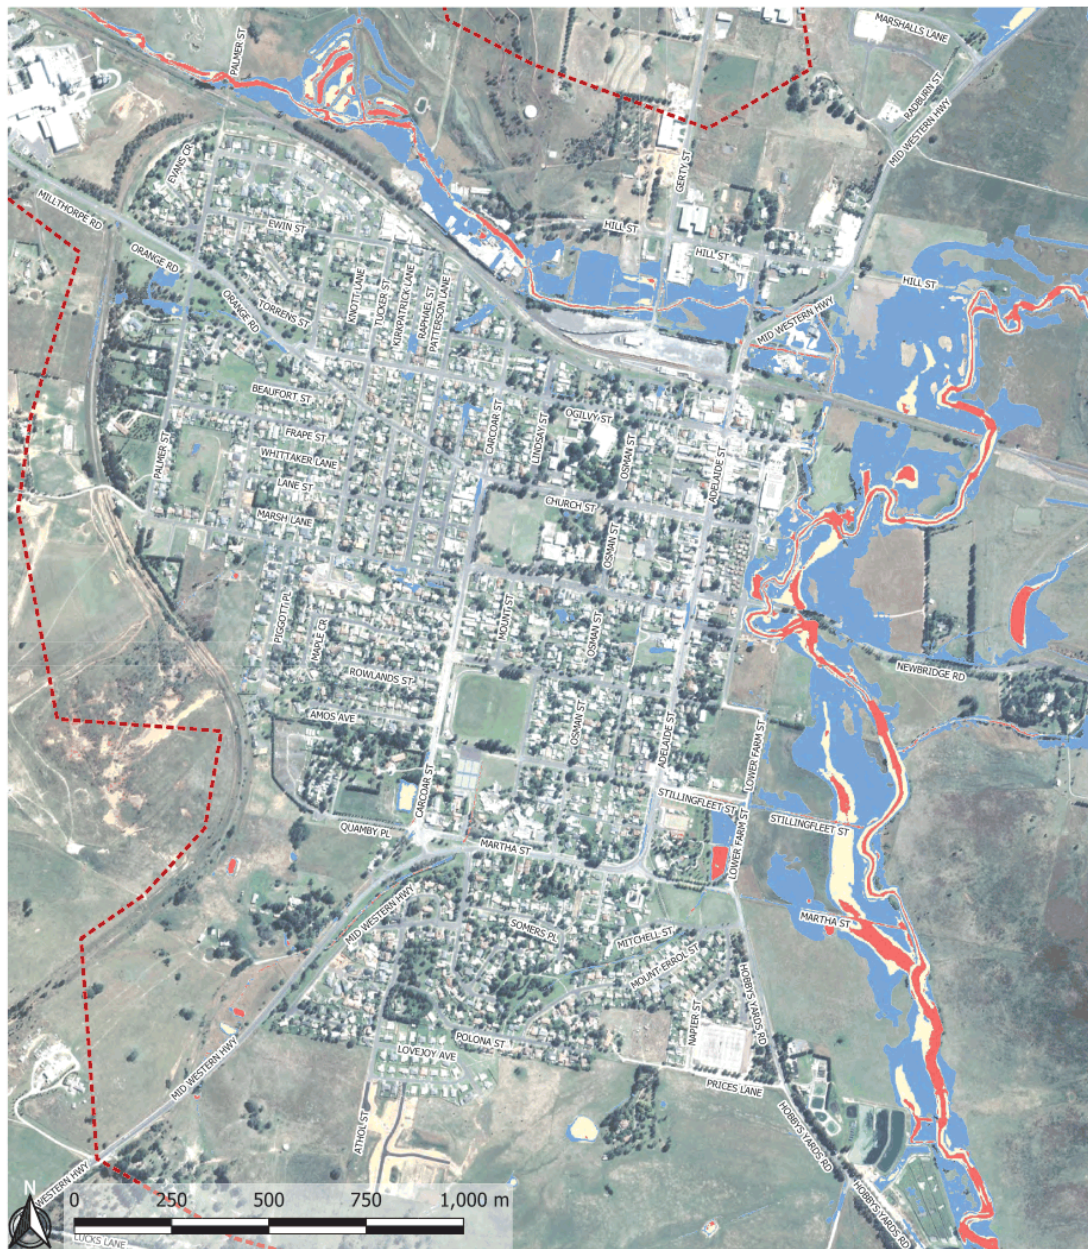
**Map 07: Existing Flood Hazard
20% AEP Event (ARR 2019)**

Note: A 150 mm cutoff depth has been applied to this map.

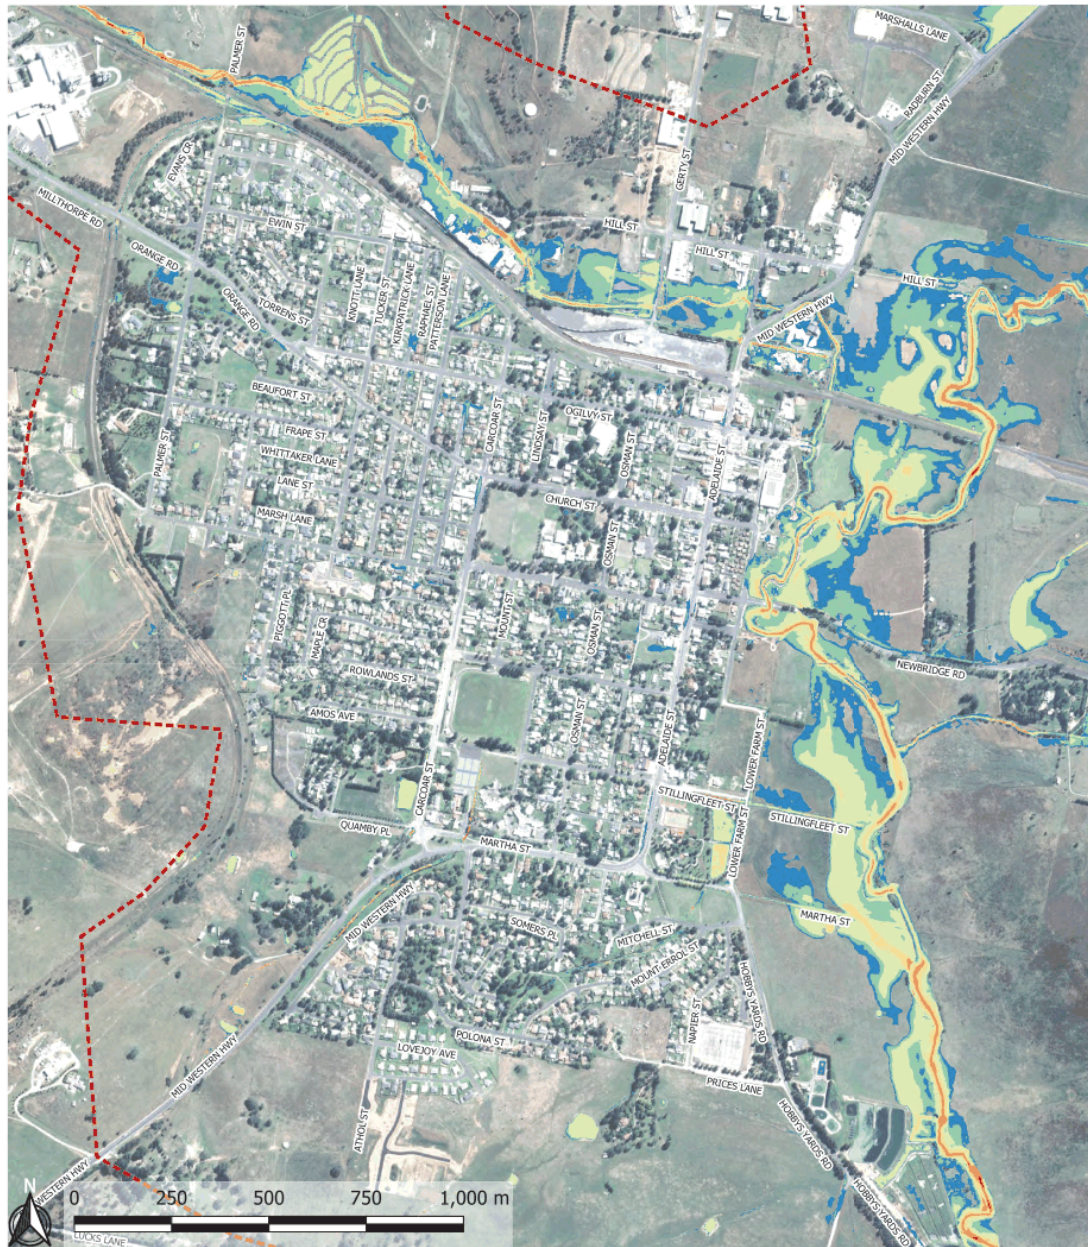
**Map 17: Proposed Without Basins Flood Hazard
20% AEP Event (ARR 2019)**

Note: A 150 mm cutoff depth has been applied to this map.

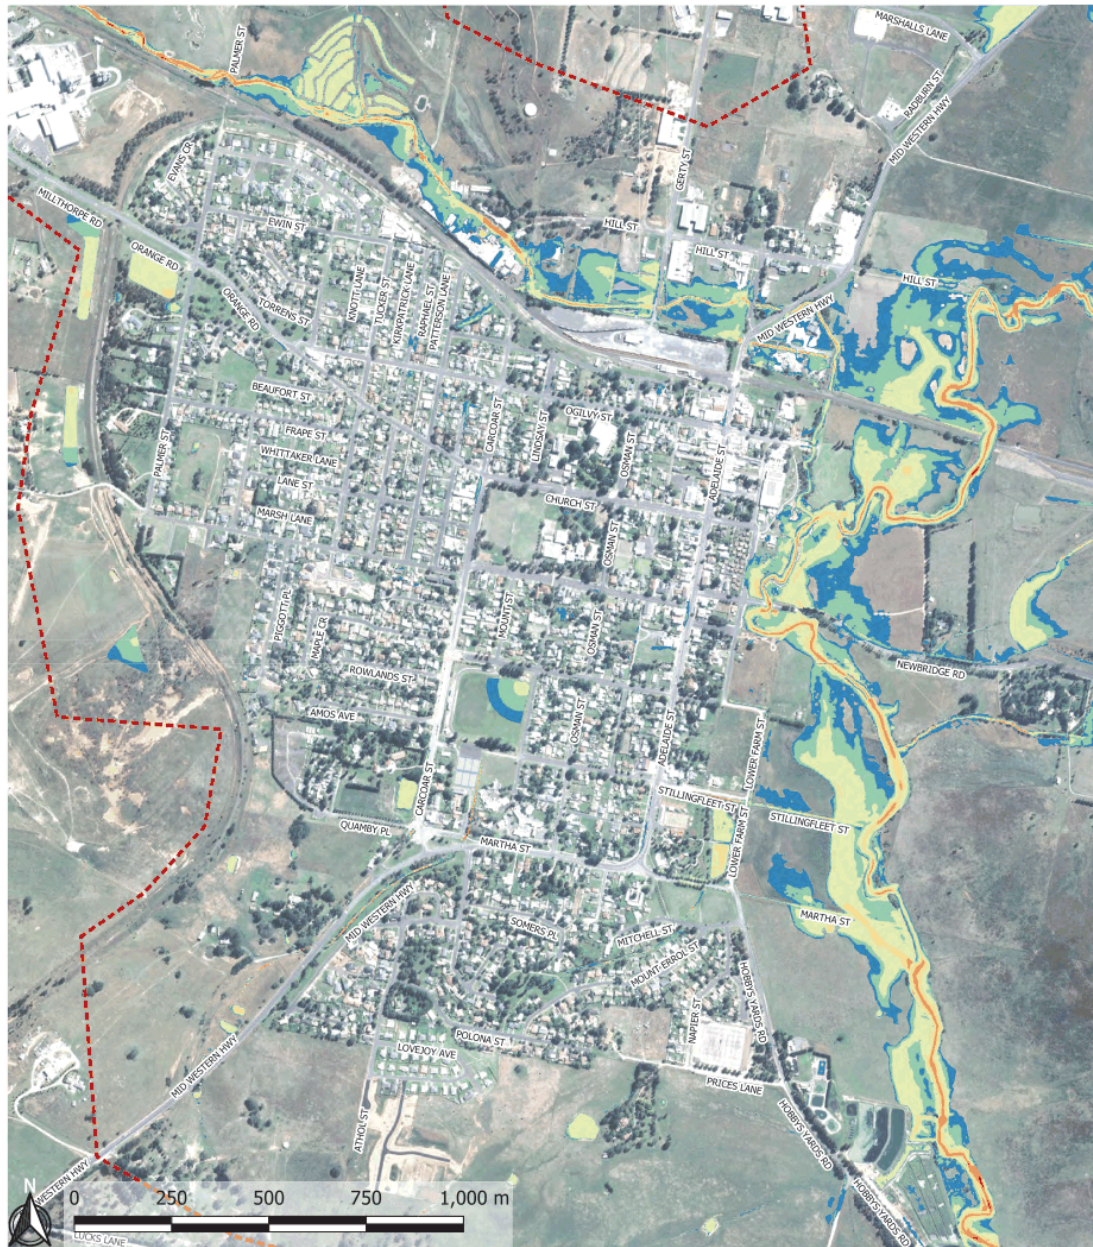
**Map 07: Proposed With Basins Flood Hazard
20% AEP Event (ARR 2019)**

Flood Hazard (ARR 2019)

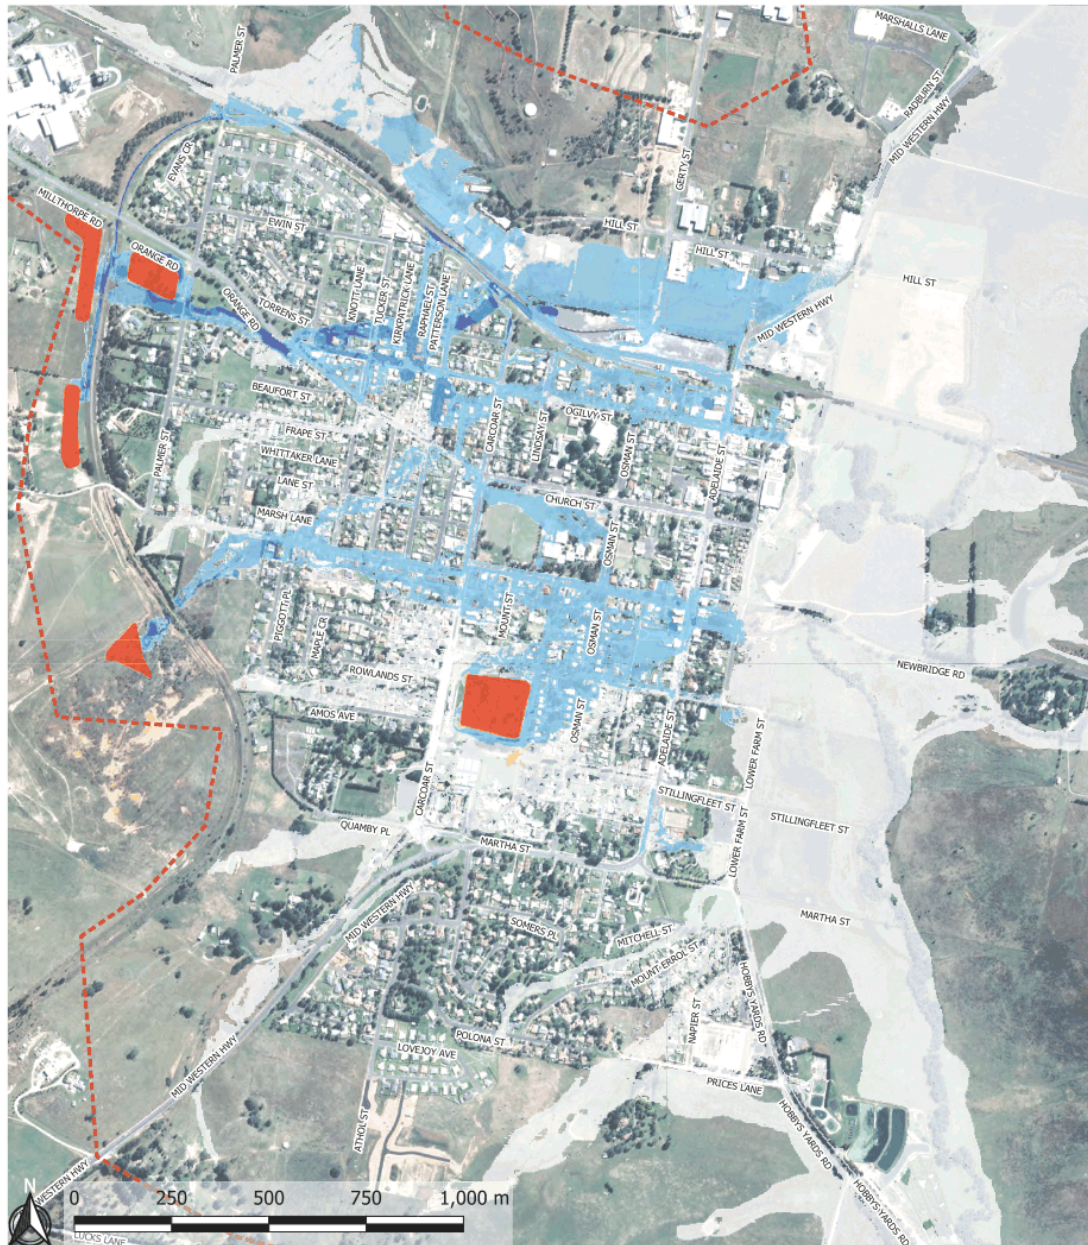
Map 10: Depth Afflux
1% AEP Event (Proposed With Basins - Proposed Without Basins)

Legend		PROJECT ID:	117-20
Depth Afflux (m)		DATE:	01.03.2022
<ul style="list-style-type: none"> <= -0.50 -0.50 - -0.20 -0.20 - -0.10 -0.10 - -0.01 -0.01 - 0.01 	<ul style="list-style-type: none"> 0.01 - 0.10 0.10 - 0.20 0.20 - 0.50 > 0.50 Model Boundary 	REVISION:	B

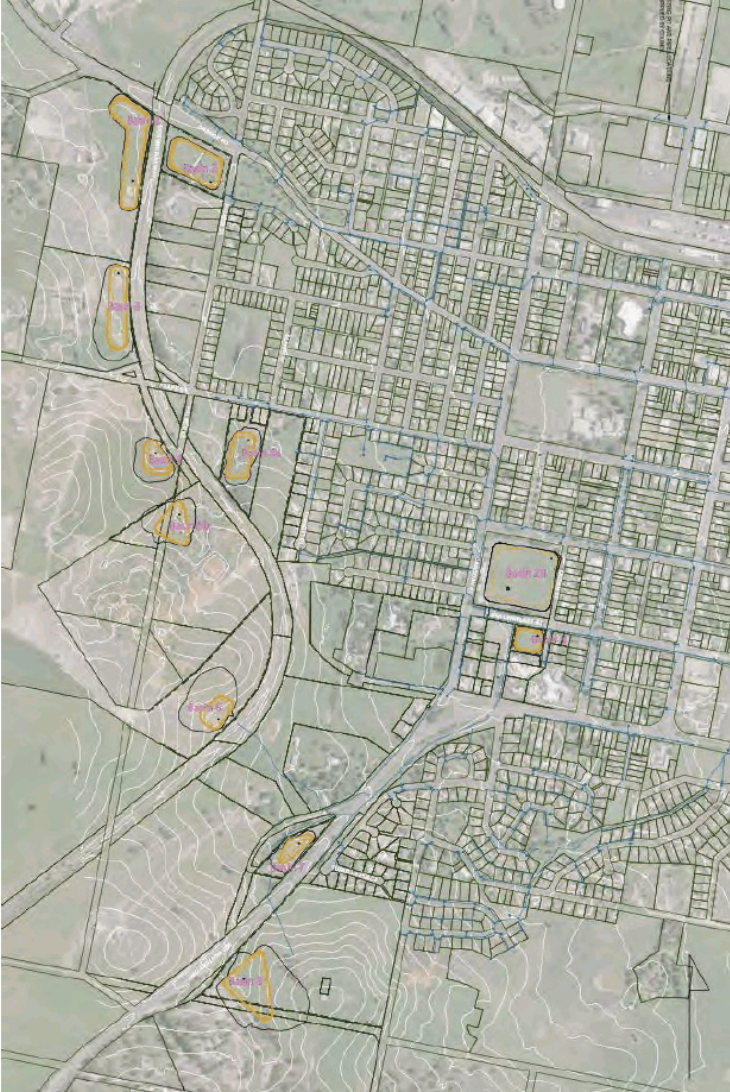
Figure 1 Locations of proposed stormwater basins around Blayney
6 | Page

Nine potential basin sites were initially identified for assessment, most of which are on private land (Figure 1). The landholder for the property where basin 8 is proposed has refused access to this site. Two basins were added later, and all the basins are predominantly located around the western and southern perimeter of Blayney, a small town in the Central Tablelands of NSW (Figure 2).

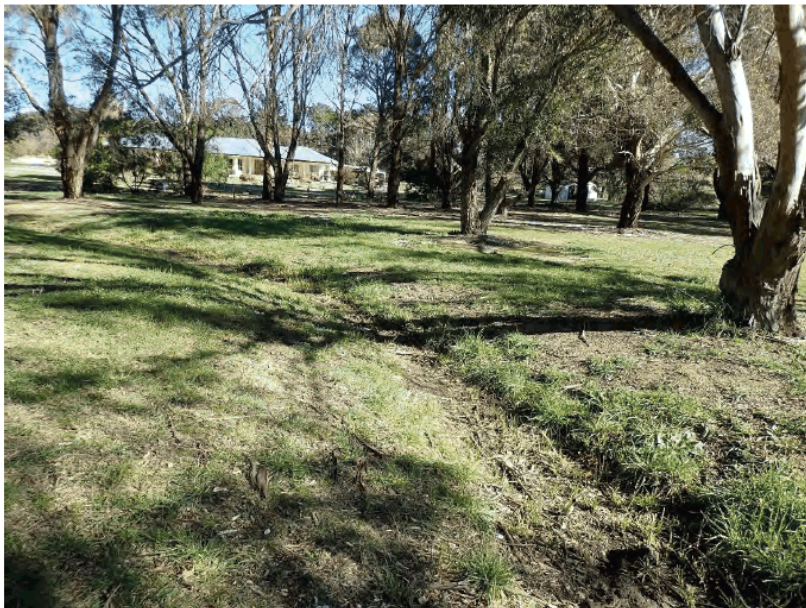
Figure 7 A small drainage swale meanders through the planted eucalypts and beside nearby housing

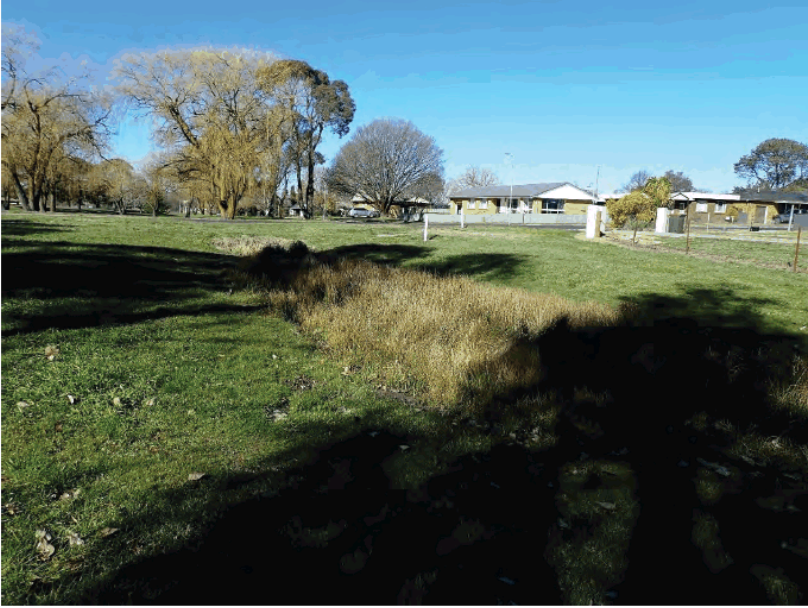
Figure 8 A small wetland area is located at the lower end of the park, near the drainage outflow

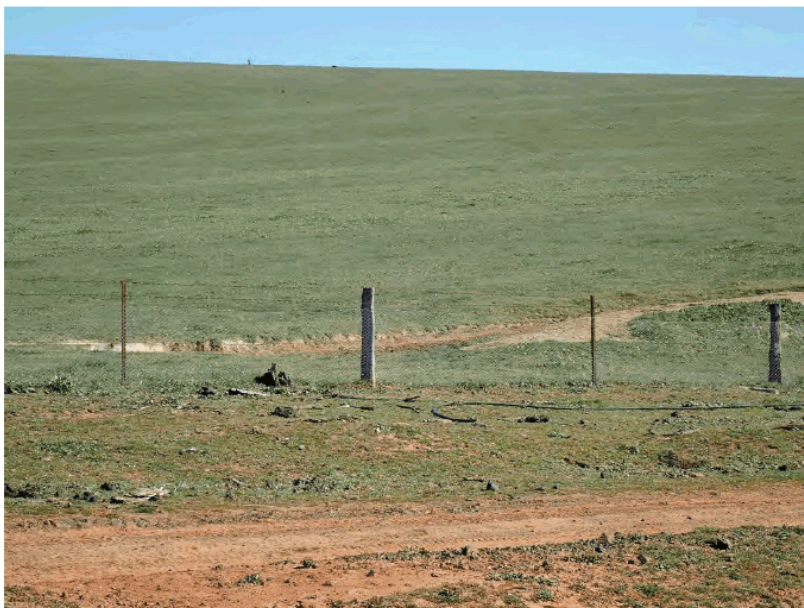
Figure 12 Basin 4 is a heavily grazed horse paddock that drains to a small dam, all located above the railway line

Basin 4 is a heavily grazed horse paddock that slopes eastward towards the Blayney – Demondrille railway line, culminating in a small dam near the eastern boundary (Figure 12). Vegetation in this location is heavily modified (Table 6), with the only native flora species present being a single specimen of Silver Wattle (*Acacia dealbata*). Trees are absent and the groundcover vegetation consists of pasture grasses and common pasture weeds. Two priority control weeds are present, namely Scotch Broom and Blackberry. Other species may be present but difficult to locate given the recent heavy grazing of the site.

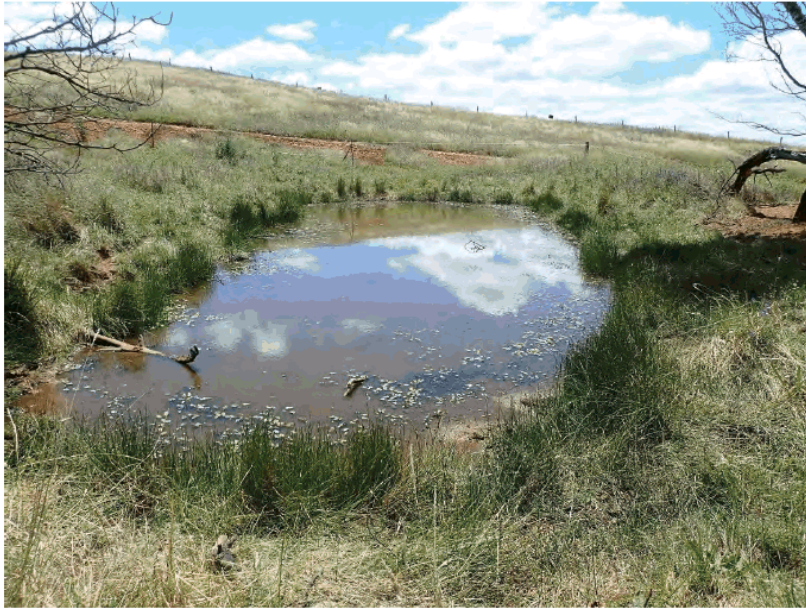
Figure 18 There is a small farm dam that is the likely site of the proposed basin

Basin 5b is located next to Basin 5a, south of Plumb St on the outskirts of Blayney. This location has evidence of historic mining and more recent erosion. A car has been dumped in the area at the base of the mining area (Figure 17). This adjoins the small farm dam that is the likely site of the proposed basin (Figure 18). This dam is surrounded by introduced grasses and a fruit tree, and has been regularly used by stock. The dam outflow has become eroded as well, indicating that the soils are likely to be highly erosive (Figure 19).

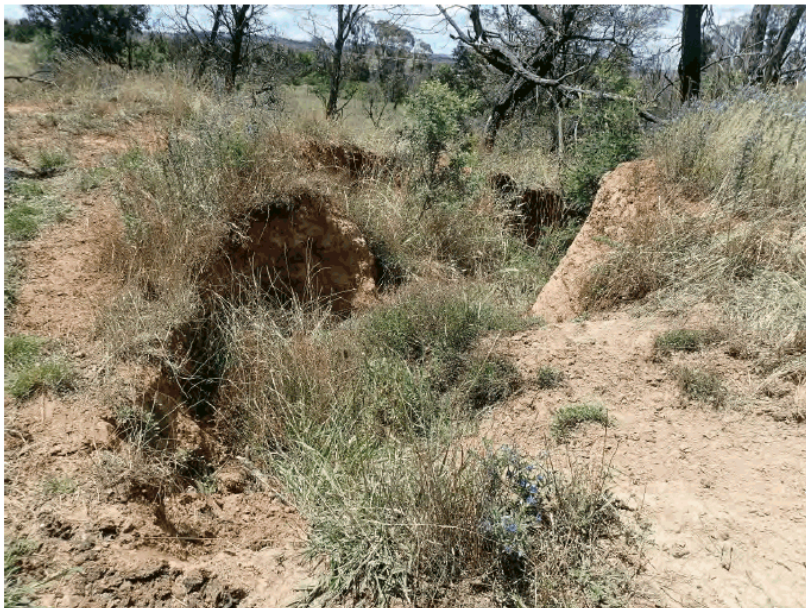
Figure 19 The dam outflow has become eroded as well, indicating that the soils are likely to be highly erosive

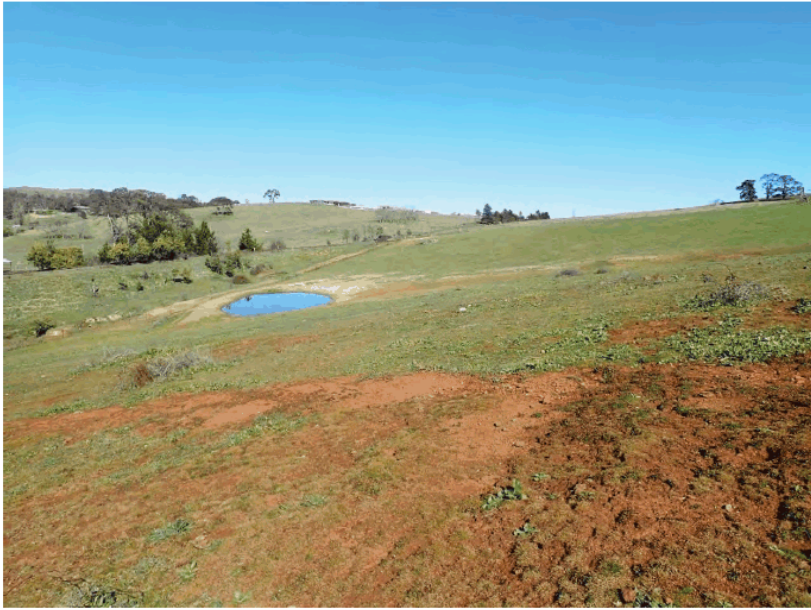
Figure 21 Basin 6 is in a heavily grazed paddock that drains to a small dam above the railway line

Basin 6 is a heavily grazed paddock that also slopes eastward towards the Blayney – Demondrille railway line, culminating in a small dam near the eastern boundary (Figure 21). Vegetation in this location is heavily modified (Table 9), with Blown Grass (*Lachnagrostis filiformis*) being the only native flora species present. Trees are absent and the groundcover vegetation consists primarily of pasture grasses and common pasture weeds. Two priority control weeds are present, namely St Johns Wort and Blackberry. Other species may be present but difficult to locate given the recent heavy grazing of the site.

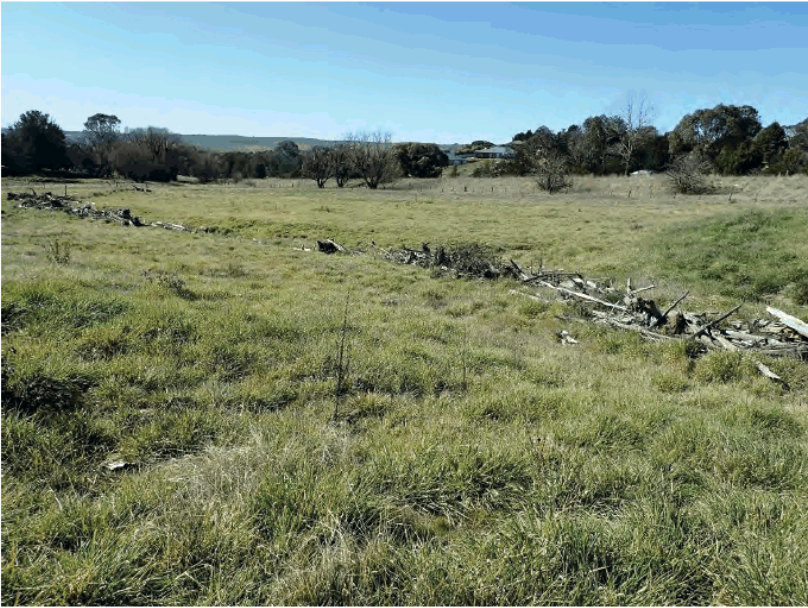
Figure 23 A swale from the dam outflow has been partially filled with willows that have been killed and dropped on site

Basin 7A includes the lower section of the area between Mid Western Highway and the old highway on the southern outskirts of Blayney. This section has been cleared in the past and has some vegetation along the old road route and a small dam (Figure 22). The outflow from the dam is conveyed from the spillway via a swale that runs to the lowest corner of the site. This swale has been filled with felled timber, most likely the remains of willows that used to be in this location (Figure 23).

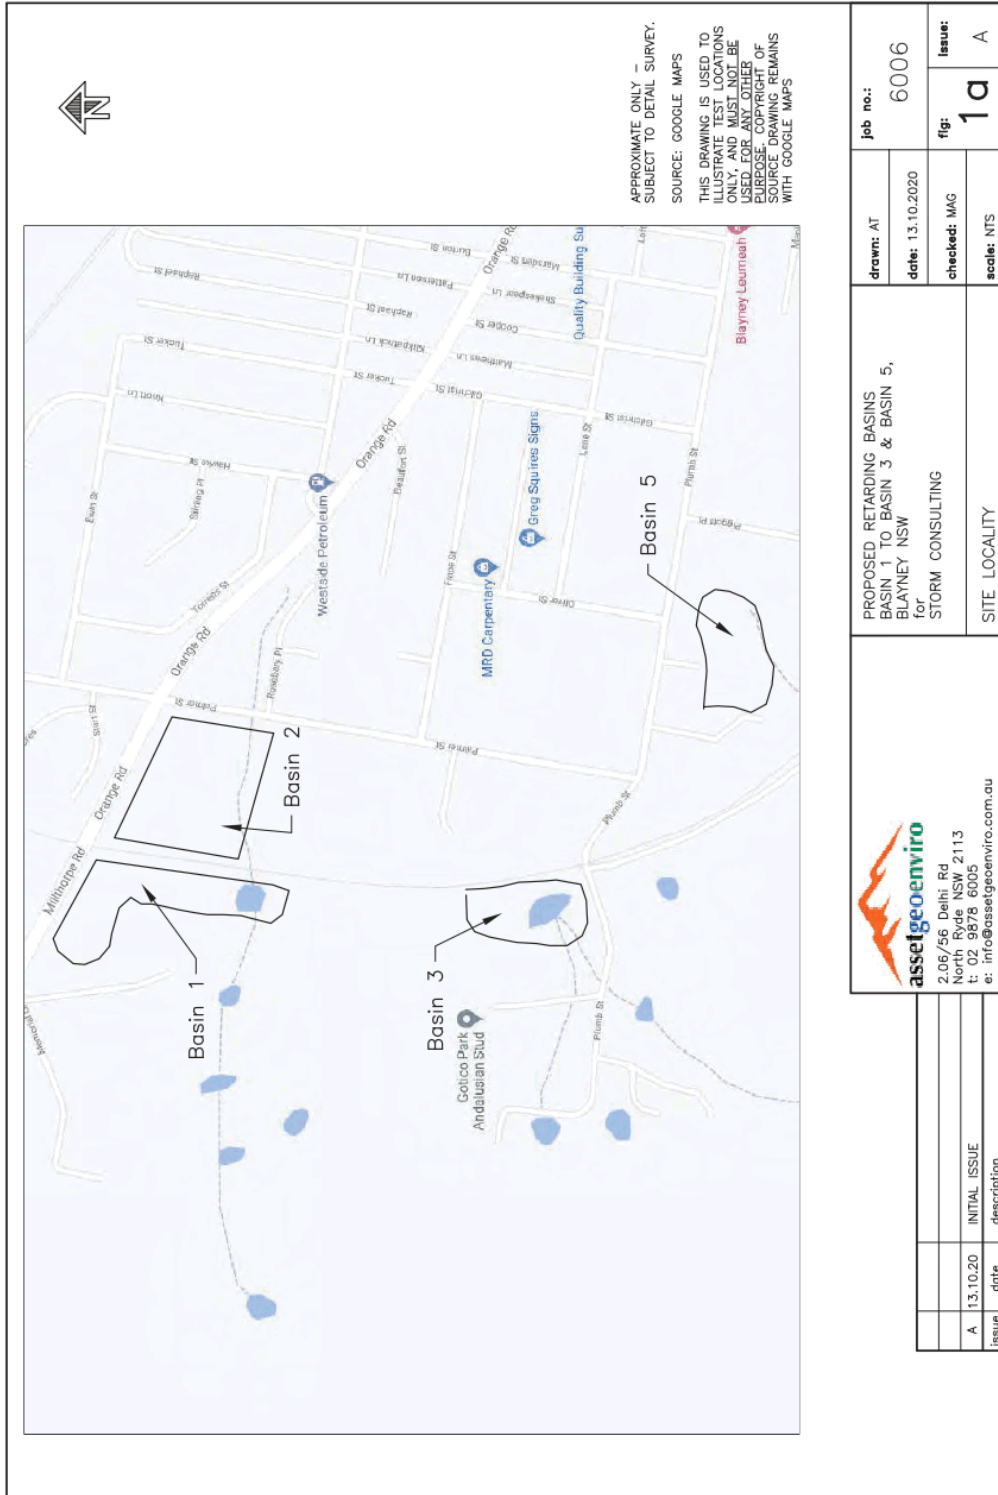
2.06/56 Delhi Rd North Ryde NSW 2113 t: 02 9878 6005 e: info@assetgeoenviro.com.au		PROPOSED RETARDING BASINS BASIN 1 TO BASIN 3 & BASIN 5, for STORM CONSULTING		drawn: AT	job no.: 6006
		SITE LOCALITY		date: 13.10.2020	fig: 1a
issue	date	description	checked: MAG	scale: NTS	issue: A
A	13.10.20	INITIAL ISSUE	checked: NTS	scale: NTS	issue: A

All sites are in and around Blayney NSW, as shown in Figures 1a/1b. Most of the sites are currently used for residential purposes. The sites are predominantly covered with grassland at the time of the investigation.

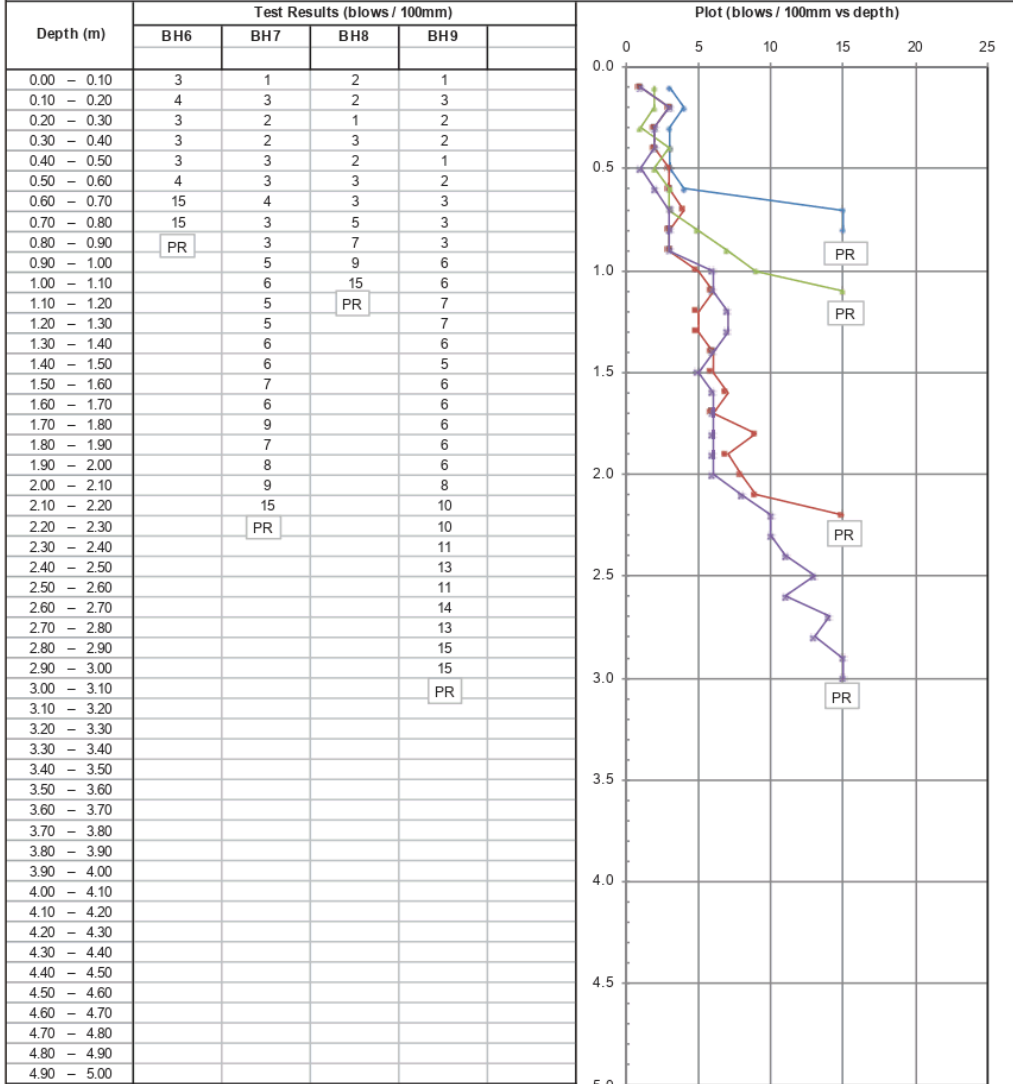
client:	Storm Consulting	started:	2/10/2020
principal:		finished:	2/10/2020
project:	Proposed Retarding Basins	logged:	AT
location:	Basin 6 to Basin 9, Blayney NSW	checked:	MAG
equipment:	9kg hammer, 510mm drop, cone tip		
standard:	AS1289.6.3.2-1997

Notes:
 RL = ground surface level (m) AHD
 TD = target depth, PR = practical refusal (15+ blows per 100mm), SR = "solid" refusal (no further penetration and "solid" ringing sound from slide hammer)

Caution must be used when inferring subsurface conditions from DCP results. Refusal can be encountered on obstructions such as gravel, cemented materials, rock floaters, or other inclusions within a soil mass. DCP testing on soils with a gravel component or cementation can indicate a higher density than actual. Also, the DCP results in clay soils are significantly affected by the in-situ moisture content. It is therefore strongly recommended that an experienced Geotechnical Engineer is engaged to confirm the inferred subsurface conditions during construction and to provide advice where subsurface conditions are significantly different.

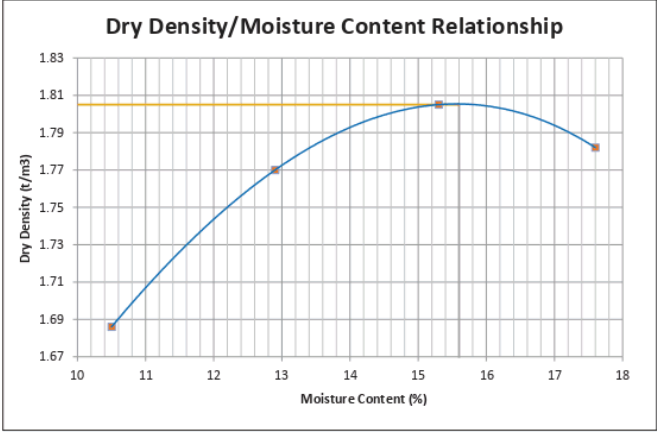
<p>Dry Density/Moisture Content Relationship</p>

DRY DENSITY / OPTIMUM MOISTURE CONTENT REPORT															
Client	AssetGeoEnviro	Source	BH1 (Basin 1)												
Address	Suite 2.05, 56 Delhi Road, North Ryde, NSW 2113	Sample Description	Silty CLAY trace of Sand and Gravel.												
Project	Proposed Retarding Basins (6006)	Report No	S63754-MDD												
Job No	S20437-1	Sample No	S63754												
Test Procedure:															
	<input checked="" type="checkbox"/> AS1289.5.1.1	Dry Density / Moisture Content Relationship - Standard Compaction													
	<input checked="" type="checkbox"/> AS1289.2.1.1	Moisture Content - Oven Drying Method (Standard Method)													
Sampling:		Sampled by Client - results apply to the sample as received	Date Sampled: 01-02/10/2020												
Preparation: Prepared in accordance with the test method

<table><tr> <td style="width: 50%;">Maximum Dry Density (t/m^3)</td> <td style="width: 50%;">1.805</td> </tr></table>

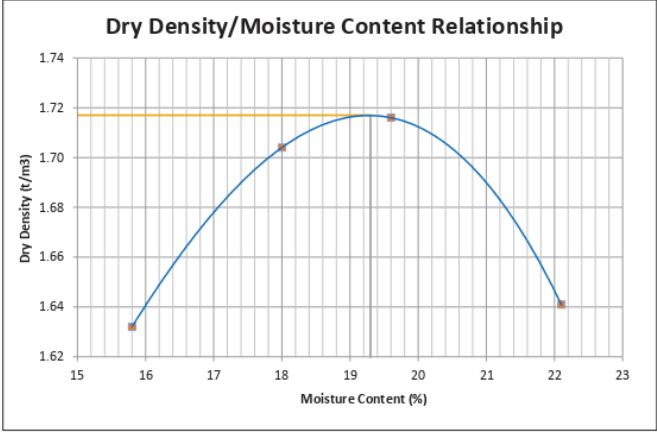
<p style="text-align: center;">Dry Density/Moisture Content Relationship</p>

DRY DENSITY / OPTIMUM MOISTURE CONTENT REPORT																
Client	AssetGeoEnviro	Source	BH2 (Basin 2)													
Address	Suite 2.05, 56 Delhi Road, North Ryde, NSW 2113	Sample Description	Silty CLAY													
Project	Proposed Retarding Basins (6006)	Report No	S63755-MDD													
Job No	S20437-1	Sample No	S63755													
Test Procedure:																
	<input checked="" type="checkbox"/> AS1289.5.1.1	Dry Density / Moisture Content Relationship - Standard Compaction														
	<input checked="" type="checkbox"/> AS1289.2.1.1	Moisture Content - Oven Drying Method (Standard Method)														
Sampling:		Sampled by Client - results apply to the sample as received	Date Sampled: 01-02/10/2020													
Preparation: Prepared in accordance with the test method

<table><tr> <td style="width: 50%;">Maximum Dry Density (t/m^3)</td> <td style="width: 50%;">1.717</td> </tr></table>

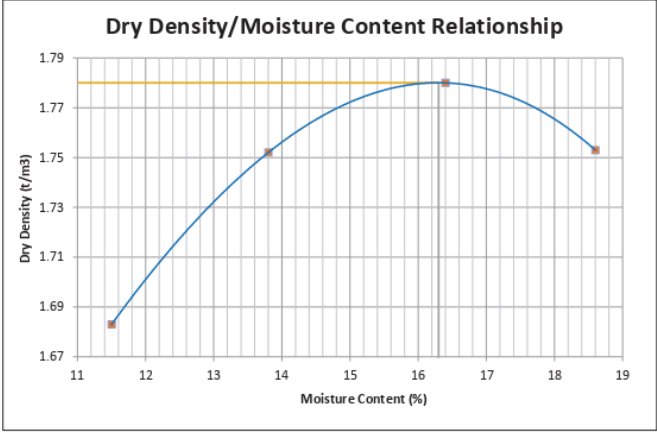
<p>Dry Density/Moisture Content Relationship</p>

DRY DENSITY / OPTIMUM MOISTURE CONTENT REPORT															
Client	AssetGeoEnviro	Source	BH3 (Basin 3)												
Address	Suite 2.05, 56 Delhi Road, North Ryde, NSW 2113	Sample Description	Silty CLAY trace of Sand and Gravel.												
Project	Proposed Retarding Basins (6006)	Report No	S63756-MDD												
Job No	S20437-1	Sample No	S63756												
Test Procedure:															
	<input checked="" type="checkbox"/> AS1289.5.1.1	Dry Density / Moisture Content Relationship - Standard Compaction													
	<input checked="" type="checkbox"/> AS1289.2.1.1	Moisture Content - Oven Drying Method (Standard Method)													
Sampling:		Sampled by Client - results apply to the sample as received	Date Sampled: 01-02/10/2020												
Preparation: Prepared in accordance with the test method

<table><tr> <td style="width: 50%;">Maximum Dry Density (t/m^3)</td> <td style="width: 50%;">1.780</td> </tr></table>

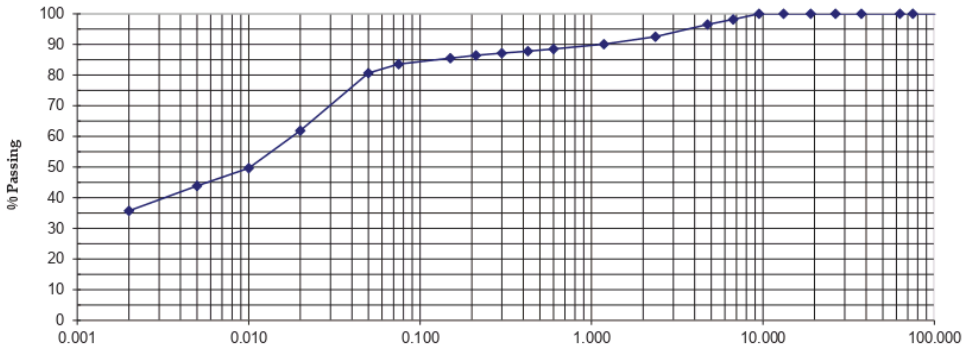
PARTICLE SIZE DISTRIBUTION (HYDROMETER) REPORT																																																																																									
Client:	AssetGeoEnviro		Source:	BH5 (Basin 5)																																																																																					
Address:	Suite 2.05, 56 Delhi Road, North Ryde, NSW 2113		Sample Description:	Silty CLAY trace of Sand and Gravel.																																																																																					
Project:	Proposed Retarding Basins (6006)		Report No.:	S63757-HYD																																																																																					
Job No.:	S20437-1		Lab No.:	S63757																																																																																					
Test Procedure:	<input checked="" type="checkbox"/> AS1289.3.6.3 Soil classification tests - Determination of the particle size distribution of a soil - Standard method of fine analysis using a hydrometer <input checked="" type="checkbox"/> AS1289.3.6.1 Soil classification tests - Determination of particle size distribution of a soil standard method sieving

<table border="1" style="width: 100%; border-collapse: collapse;"> <thead> <tr> <th style="width: 15%;">Sieve Aperture: (mm)</th> <th style="width: 10%;">%</th> <th style="width: 20%;">Specification (.)</th> <th style="width: 15%;">Sieve Aperture: (mm)</th> <th style="width: 10%;">%</th> <th style="width: 25%;">Specification (.)</th> </tr> <tr> <td></td> <td>Passing</td> <td>Envelope</td> <td></td> <td>Passing</td> <td>Envelope</td> </tr> </thead> <tbody> <tr> <td>200</td> <td>-</td> <td></td> <td>1.180</td> <td>90</td> <td></td> </tr> <tr> <td>75</td> <td>-</td> <td></td> <td>0.600</td> <td>88</td> <td></td> </tr> <tr> <td>63</td> <td>-</td> <td></td> <td>0.425</td> <td>88</td> <td></td> </tr> <tr> <td>37.5</td> <td>-</td> <td></td> <td>0.300</td> <td>87</td> <td></td> </tr> <tr> <td>26.5</td> <td>-</td> <td></td> <td>0.212</td> <td>86</td> <td></td> </tr> <tr> <td>19.0</td> <td>-</td> <td></td> <td>0.150</td> <td>86</td> <td></td> </tr> <tr> <td>13.2</td> <td>-</td> <td></td> <td>0.075</td> <td>84</td> <td></td> </tr> <tr> <td>9.5</td> <td>100</td> <td></td> <td>0.050</td> <td>81</td> <td></td> </tr> <tr> <td>6.7</td> <td>98</td> <td></td> <td>0.020</td> <td>62</td> <td></td> </tr> <tr> <td>4.75</td> <td>97</td> <td></td> <td>0.010</td> <td>50</td> <td></td> </tr> <tr> <td>2.36</td> <td>93</td> <td></td> <td>0.005</td> <td>44</td> <td></td> </tr> <tr> <td></td> <td></td> <td></td> <td>0.002</td> <td>36</td> <td></td> </tr> </tbody> </table>						Sieve Aperture: (mm)	%	Specification (.)	Sieve Aperture: (mm)	%	Specification (.)		Passing	Envelope		Passing	Envelope	200	-		1.180	90		75	-		0.600	88		63	-		0.425	88		37.5	-		0.300	87		26.5	-		0.212	86		19.0	-		0.150	86		13.2	-		0.075	84		9.5	100		0.050	81		6.7	98		0.020	62		4.75	97		0.010	50		2.36	93		0.005	44					0.002	36

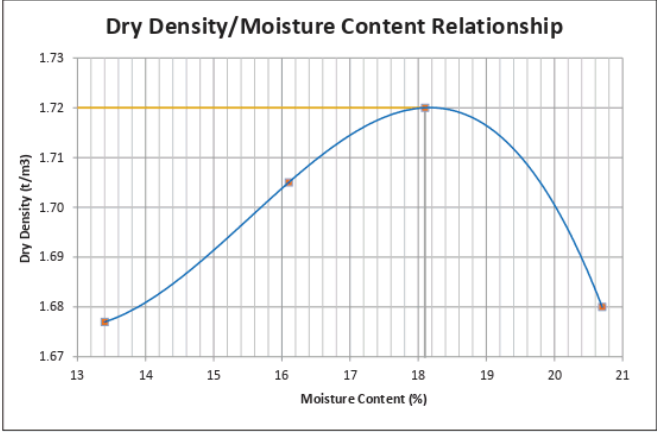
<p style="text-align: center;">Dry Density/Moisture Content Relationship</p>

DRY DENSITY / OPTIMUM MOISTURE CONTENT REPORT															
Client	AssetGeoEnviro	Source	BH5 (Basin 5)												
Address	Suite 2.05, 56 Delhi Road, North Ryde, NSW 2113	Sample Description	Silty CLAY trace of Sand and Gravel.												
Project	Proposed Retarding Basins (6006)	Report No	S63757-MDD												
Job No	S20437-1	Sample No	S63757												
Test Procedure:															
	<input checked="" type="checkbox"/> AS1289.5.1.1	Dry Density / Moisture Content Relationship - Standard Compaction													
	<input checked="" type="checkbox"/> AS1289.2.1.1	Moisture Content - Oven Drying Method (Standard Method)													
Sampling:		Sampled by Client - results apply to the sample as received	Date Sampled: 01-02/10/2020												
Preparation: Prepared in accordance with the test method

<table><tr> <td style="width: 50%;">Maximum Dry Density (t/m^3)</td> <td style="width: 50%;">1.720</td> </tr></table>

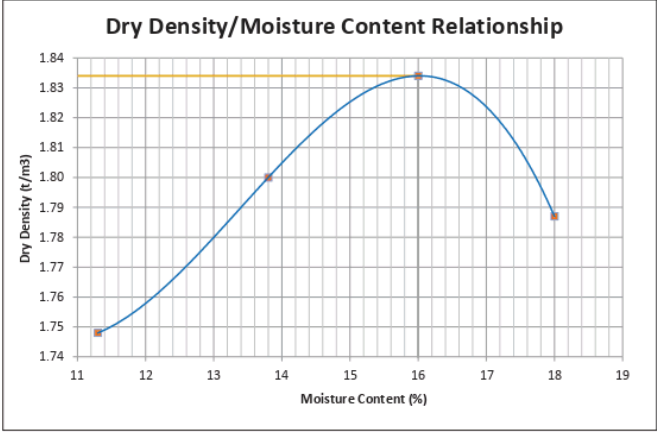
<p>Dry Density/Moisture Content Relationship</p>

DRY DENSITY / OPTIMUM MOISTURE CONTENT REPORT															
Client	AssetGeoEnviro	Source	BH6 (Basin 6)												
Address	Suite 2.05, 56 Delhi Road, North Ryde, NSW 2113	Sample Description	Silty CLAY with Sand and Gravel.												
Project	Proposed Retarding Basins (6006)	Report No	S63758-MDD												
Job No	S20437-1	Sample No	S63758												
Test Procedure:															
	<input checked="" type="checkbox"/> AS1289.5.1.1	Dry Density / Moisture Content Relationship - Standard Compaction													
	<input checked="" type="checkbox"/> AS1289.2.1.1	Moisture Content - Oven Drying Method (Standard Method)													
Sampling:		Sampled by Client - results apply to the sample as received	Date Sampled: 01-02/10/2020												
Preparation: Prepared in accordance with the test method

<table><tr> <td style="width: 50%;">Maximum Dry Density (t/m^3)</td> <td style="width: 50%;">1.834</td> </tr></table>

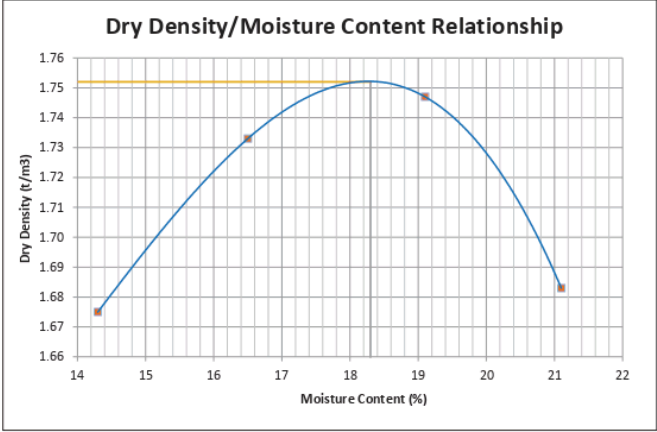
<p style="text-align: center;">Dry Density/Moisture Content Relationship</p>

DRY DENSITY / OPTIMUM MOISTURE CONTENT REPORT															
Client	AssetGeoEnviro	Source	BH7 (Basin 7)												
Address	Suite 2.05, 56 Delhi Road, North Ryde, NSW 2113	Sample Description	Silty CLAY trace of Sand and Gravel.												
Project	Proposed Retarding Basins (6006)	Report No	S63759-MDD												
Job No	S20437-1	Sample No	S63759												
Test Procedure:	<input checked="" type="checkbox"/> AS1289.5.1.1 Dry Density / Moisture Content Relationship - Standard Compaction <input checked="" type="checkbox"/> AS1289.2.1.1 Moisture Content - Oven Drying Method (Standard Method)														
Sampling:	Sampled by Client - results apply to the sample as received		Date Sampled: 01-02/10/2020												
Preparation:	Prepared in accordance with the test method

<table><tr> <td style="padding: 2px;">Maximum Dry Density (t/m^3)</td> <td style="padding: 2px;">1.752</td> </tr></table>

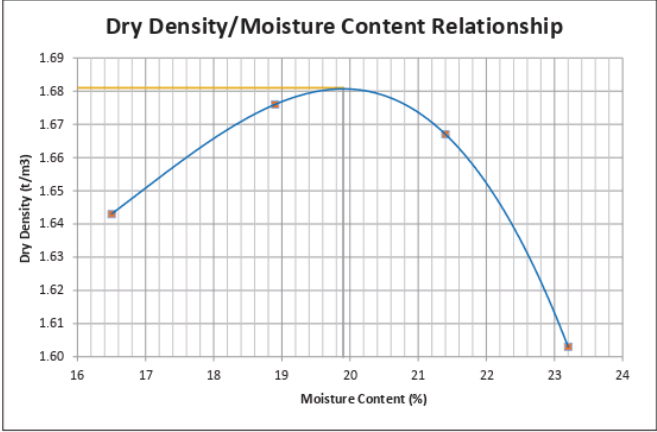
<p style="text-align: center;">Dry Density/Moisture Content Relationship</p>

DRY DENSITY / OPTIMUM MOISTURE CONTENT REPORT															
Client	AssetGeoEnviro	Source	BH8 (Basin 8)												
Address	Suite 2.05, 56 Delhi Road, North Ryde, NSW 2113	Sample Description	Silty CLAY												
Project	Proposed Retarding Basins (6006)	Report No	S63760-MDD												
Job No	S20437-1	Sample No	S63760												
Test Procedure:															
	<input checked="" type="checkbox"/> AS1289.5.1.1	Dry Density / Moisture Content Relationship - Standard Compaction													
	<input checked="" type="checkbox"/> AS1289.2.1.1	Moisture Content - Oven Drying Method (Standard Method)													
Sampling:		Sampled by Client - results apply to the sample as received	Date Sampled: 01-02/10/2020												
Preparation: Prepared in accordance with the test method

<table><tr> <td style="padding: 2px;">Maximum Dry Density (t/m^3)</td> <td style="text-align: right; padding: 2px;">1.681</td> </tr></table>
