**ATTACHMENTS TO REPORTS OF THE BLAYNEY SHIRE COUNCIL MEETING
HELD ON MONDAY 16 MAY 2022**

11 Floodplain Management

Addendum to Blayney Flood Study
Update to Australian Rainfall and Runoff 2019 Guidelines

For Blayney Shire Council

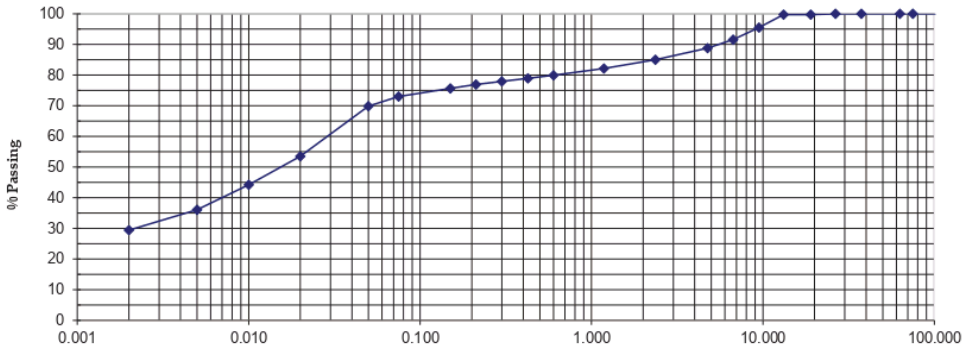
PARTICLE SIZE DISTRIBUTION (HYDROMETER) REPORT																																																																																									
Client:	AssetGeoEnviro		Source:	BH9 (Basin 9)																																																																																					
Address:	Suite 2.05, 56 Delhi Road, North Ryde, NSW 2113		Sample Description:	Silty CLAY trace of Gravel and Sand.																																																																																					
Project:	Proposed Retarding Basins (6006)		Report No.:	S63761-HYD																																																																																					
Job No.:	S20437-1		Lab No.:	S63761																																																																																					
Test Procedure: <input checked="" type="checkbox"/> AS1289.3.6.3 Soil classification tests - Determination of the particle size distribution of a soil - Standard method of fine analysis using a hydrometer <input checked="" type="checkbox"/> AS1289.3.6.1 Soil classification tests - Determination of particle size distribution of a soil standard method sieving

<table border="1" style="width: 100%; border-collapse: collapse;"> <thead> <tr> <th style="width: 15%;">Sieve Aperture: (mm)</th> <th style="width: 10%;">%</th> <th style="width: 20%;">Specification (.)</th> <th style="width: 15%;">Sieve Aperture: (mm)</th> <th style="width: 10%;">%</th> <th style="width: 25%;">Specification (.)</th> </tr> <tr> <td></td> <td>Passing</td> <td>Envelope</td> <td></td> <td>Passing</td> <td>Envelope</td> </tr> </thead> <tbody> <tr><td>200</td><td>-</td><td></td><td>1.180</td><td>82</td><td></td></tr> <tr><td>75</td><td>-</td><td></td><td>0.600</td><td>80</td><td></td></tr> <tr><td>63</td><td>-</td><td></td><td>0.425</td><td>79</td><td></td></tr> <tr><td>37.5</td><td>-</td><td></td><td>0.300</td><td>78</td><td></td></tr> <tr><td>26.5</td><td>100</td><td></td><td>0.212</td><td>77</td><td></td></tr> <tr><td>19.0</td><td>100</td><td></td><td>0.150</td><td>76</td><td></td></tr> <tr><td>13.2</td><td>100</td><td></td><td>0.075</td><td>73</td><td></td></tr> <tr><td>9.5</td><td>96</td><td></td><td>0.050</td><td>70</td><td></td></tr> <tr><td>6.7</td><td>92</td><td></td><td>0.020</td><td>54</td><td></td></tr> <tr><td>4.75</td><td>89</td><td></td><td>0.010</td><td>44</td><td></td></tr> <tr><td>2.36</td><td>85</td><td></td><td>0.005</td><td>36</td><td></td></tr> <tr><td></td><td></td><td></td><td>0.002</td><td>29</td><td></td></tr> </tbody> </table>						Sieve Aperture: (mm)	%	Specification (.)	Sieve Aperture: (mm)	%	Specification (.)		Passing	Envelope		Passing	Envelope	200	-		1.180	82		75	-		0.600	80		63	-		0.425	79		37.5	-		0.300	78		26.5	100		0.212	77		19.0	100		0.150	76		13.2	100		0.075	73		9.5	96		0.050	70		6.7	92		0.020	54		4.75	89		0.010	44		2.36	85		0.005	36					0.002	29

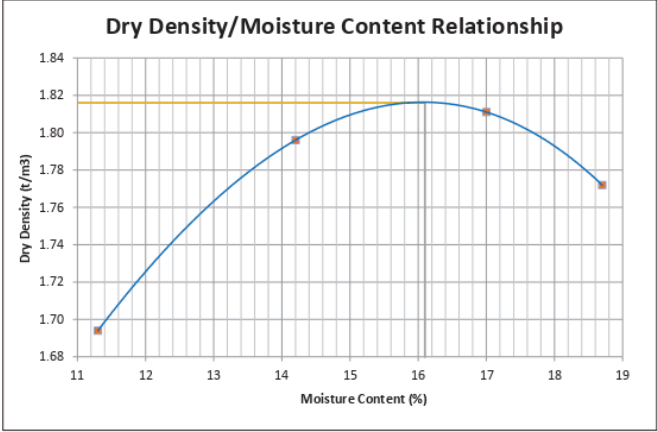
<p style="text-align: center;">Dry Density/Moisture Content Relationship</p>

DRY DENSITY / OPTIMUM MOISTURE CONTENT REPORT															
Client	AssetGeoEnviro	Source	BH9 (Basin 9)												
Address	Suite 2.05, 56 Delhi Road, North Ryde, NSW 2113	Sample Description	Silty CLAY trace of Gravel and Sand.												
Project	Proposed Retarding Basins (6006)	Report No	S63761-MDD												
Job No	S20437-1	Sample No	S63761												
Test Procedure:															
	<input checked="" type="checkbox"/> AS1289.5.1.1	Dry Density / Moisture Content Relationship - Standard Compaction													
	<input checked="" type="checkbox"/> AS1289.2.1.1	Moisture Content - Oven Drying Method (Standard Method)													
Sampling:		Sampled by Client - results apply to the sample as received	Date Sampled: 01-02/10/2020												
Preparation: Prepared in accordance with the test method

<table><tr> <td style="padding: 2px;">Maximum Dry Density (t/m^3)</td> <td style="padding: 2px;">1.816</td> </tr></table>
